# Mine Subsidence Repair

## PROJECT

Stabilize house damaged by long-wall coal mining.

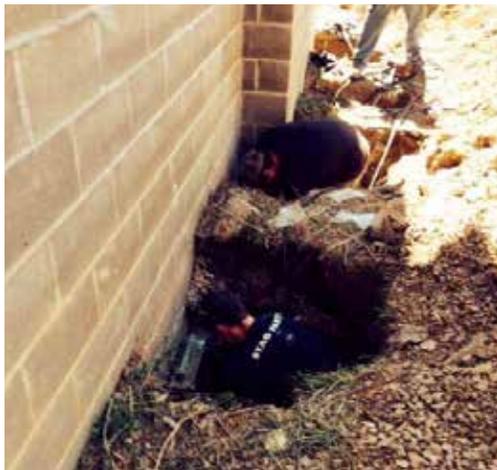
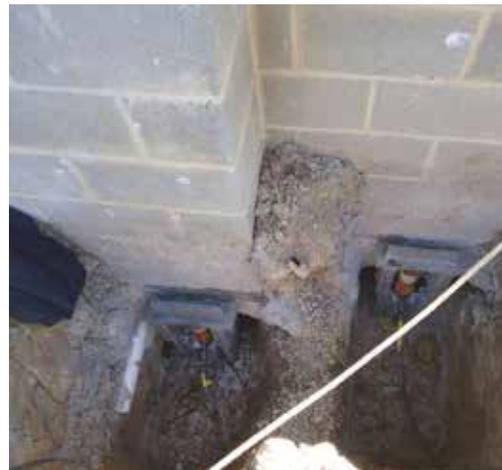
The homeowners built a new house in West Virginia in 2011, but it was not long before they noticed some problems. By 2012 it was clear that one corner of the house was dropping. Not good, but not unusual in an area known for its coal mines. By the time the ground stabilized in 2013, one basement wall was damaged beyond repair and the wood-framed house above was out of square and damaged.

Atlas Resistance Piers were installed outside of the house along one wall and inside the basement along another wall. To get to the footer, workers dug down on the outside of the house and cut through the concrete floor in the basement. Workers undermined the footer, where necessary, to mount the brackets and prepare for pile installation. The bracket is bolted to the underside of the footer and extends out besides the footer. The piers are installed vertically, through the bracket. Unlike Helical Piles, which are screwed in, Atlas Resistance® Piers are forced into the ground hydraulically.

Smith and his team installed 12 piers that were all 3-1/2 inch diameter pipe piers with one full pipe extension for a total depth of 7’ at each location.
